**Title: Heritage Construction Systems: Characteristics and Case Studies in Costa Rica.
From a historical perspective that allows us to understand the evolution of
construction systems, identifying the cultural and technological influences that shaped
these techniques.**

Written by Asline Solano Leitón

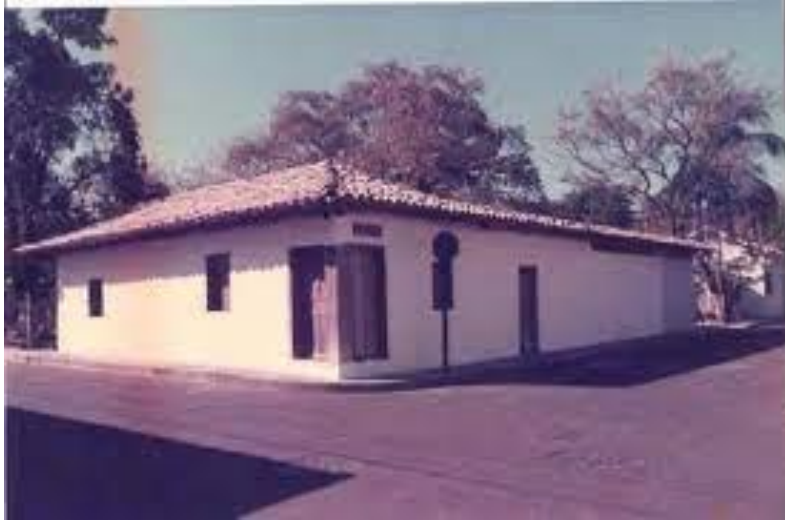
Notes The previous photograph shows the house Esperanza Castillo Rovira en Liberia, Guanacaste. Declared Historical-architectural Heritage on September 19, 2014 under decree #38535-C, Gaceta #180. IPhotography1.
<https://micostaricadeantano.com/2020/12/16/casa-de-la-cultura-liberia-guanacaste-1851-1900/>

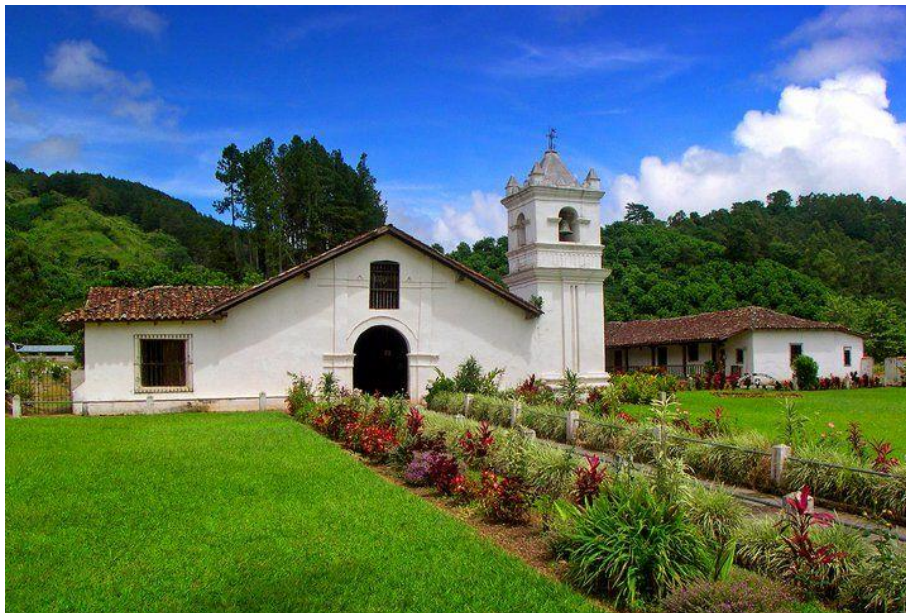
Notes. The previous photograph shows the San José de Orosi church, Cartago IPhotography1. <https://www.muniparaiso.go.cr/lugar/13/iglesia-de-orosi>

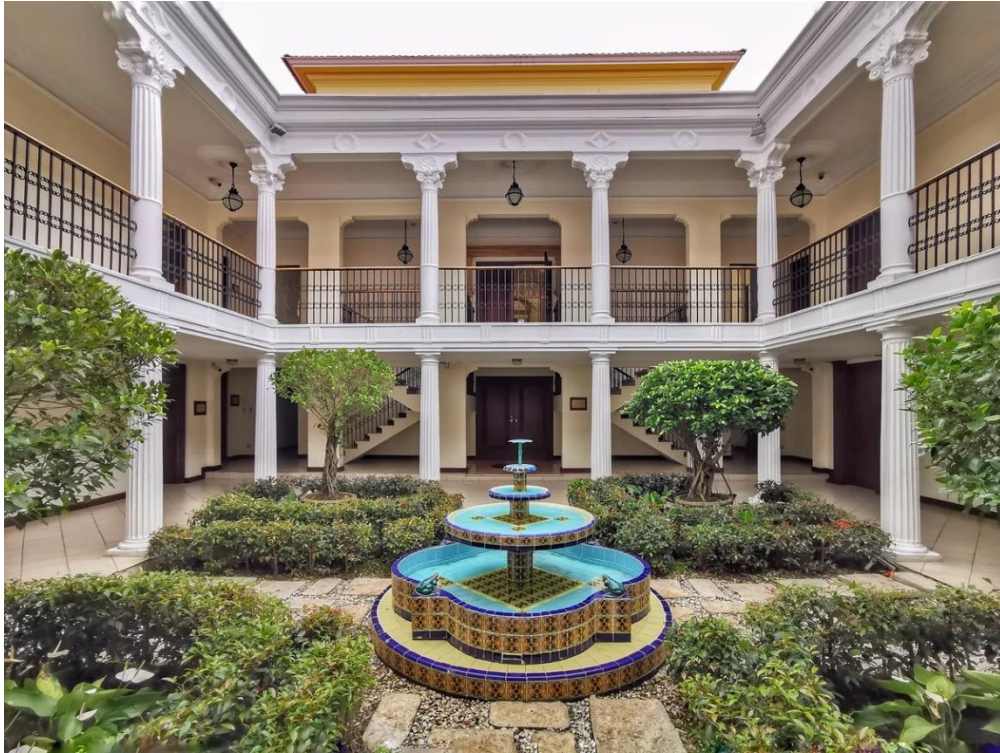
Notes The photo above shows the Casa Amarilla, San José IPhotography1. Fuente: El Ministerio de Relaciones Exteriores y Culto. <https://www.chepetown.com/blog/casaamarilla>

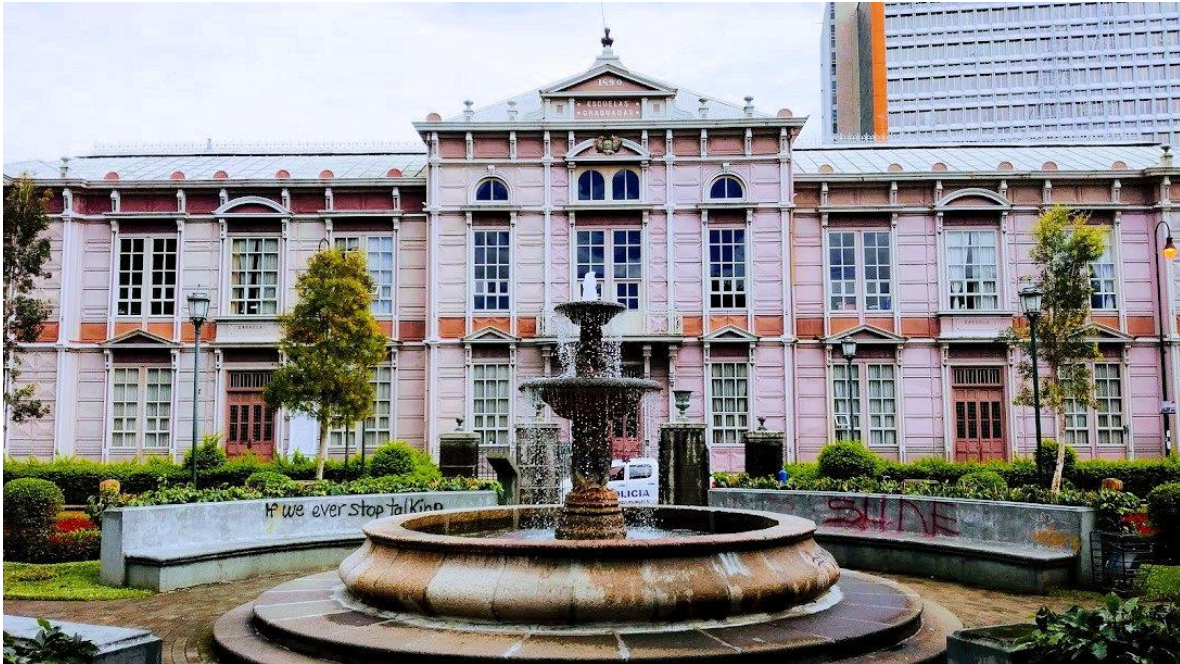
Notes. The previous photograph shows the Buenaventura Corrales Bermúdez School, San José IPhotography1. <https://cambiopolitico.com/el-edificio-metalico/88102/>

An example of this architecture is the Buenaventura Corrales Bermúdez School, known as the "Edificio Metálico" (metallic building). This structure holds great value for Costa Rica,

both architecturally and symbolically, as it represents the materials of the educational reform by the liberals and stands as clear evidence of the scope of popular education.

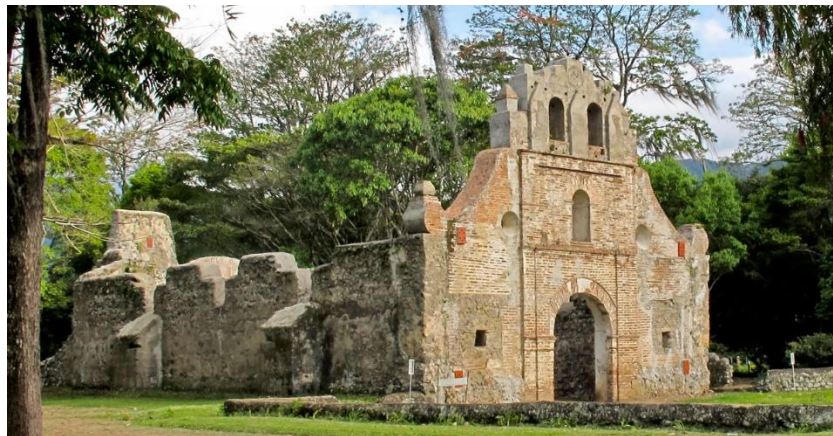
Notes. The previous photograph shows the ruins of Ujarrás, Cartago IPhotography1. <https://www.muniparaiso.go.cr/lugar/14/las-ruinas-de-ujarras>

The Ujarrás Ruins primarily consist of the remains of an old colonial church built in 1693 and expanded in the 18th century. The church is dedicated to the Virgin of the Immaculate Conception. Now, I will describe the architectural and structural aspects of the ruins:

Floor Plan and Layout: The Ujarrás Church was constructed with a rectangular floor plan, typical of colonial churches in Costa Rica. The main nave extended longitudinally and was flanked by two side chapels. The main entrance is on the western façade, and the main altar is at the opposite end.

Construction Materials: The Ujarrás Ruins were mainly built using sun-dried adobe bricks, a common construction technique during the colonial era. Adobe involves mud bricks dried in the sun and bonded with lime mortar. Stone is also used in corners and structurally significant areas to reinforce the structure.

Walls and Foundations: The church walls are thick and solid, showcasing a robust and durable structure. These walls serve a crucial structural function, supporting the weight of the roof and other architectural elements. The foundation is made of stone to ensure the stability of the structure.

Roof and Rooftop: The church roof is a gabled roof, typical of Spanish colonial architecture. It was probably constructed with a wooden framework and covered with clay tiles. Unfortunately, over time and due to neglect, the original roof covering has likely been largely lost.
